Regulatory Inspection Summary Report

Hunters Point Naval Shipyard

Inspection Date: June 9, 2017 Time: 9:10am to 11:30pm

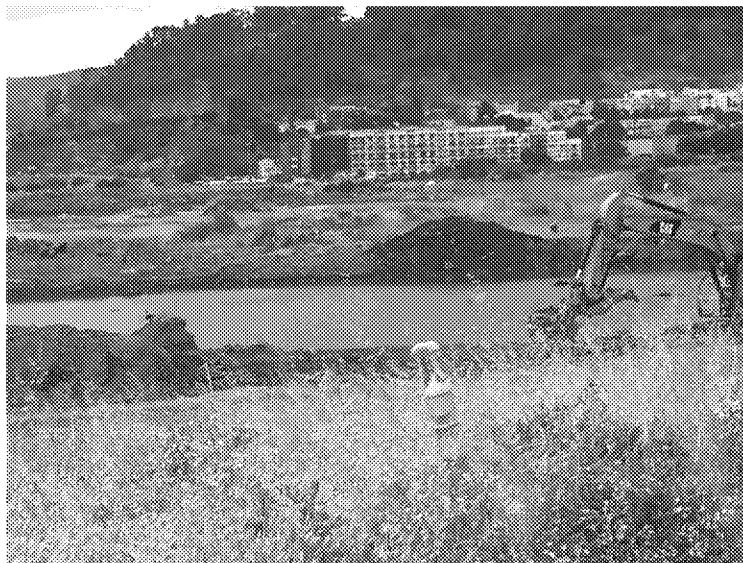
During the tour, we witnessed a wetlands restoration in Parcel E-2. As the crew dug deeper, the land naturally filled with water. Someone noted a slight petroleum smell escaping from the area, was not determined if the odor is coming from the machinery or the soil. Someone also had mentioned methane due to odors, but it was nothing of concern. At this point, our guide noted that the rain that occurred on Thursday June 8 was so mild that it was hardly noticeable in Hunter's Point.

Image 1. Wetland restoration in Parcel E-2.

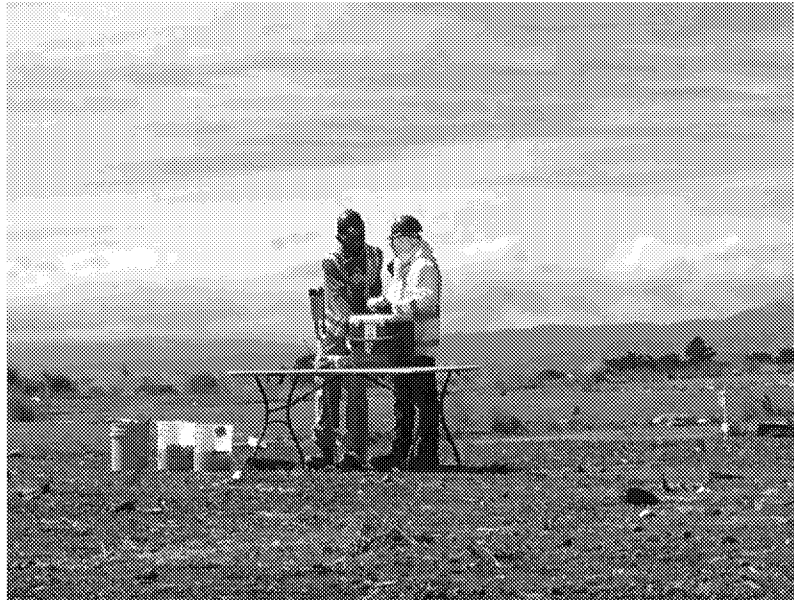
Image 2. Ongoing Sample efforts. Crewmembers taking a soil core.

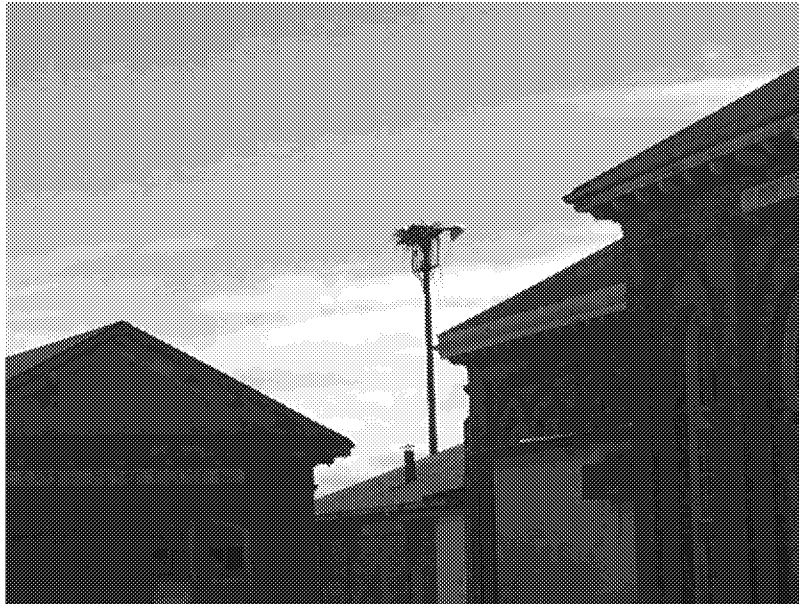
Image 3. Osprey nest on lamp post in Parcel C.

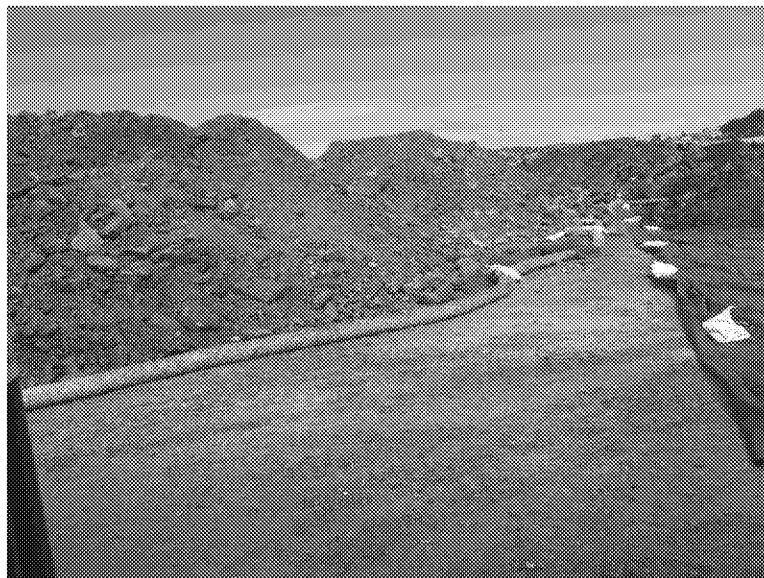
In response to the Hunter's Point residents' complaints, we saw the contractors spraying the dirt roads with water from a truck in an attempt to keep the soil moist and not suspended in the air. After the soil is sifted, the contractors separate each substance found into piles and spray each pile with a clear or green soil adhesive to keep particles from each pile blowing away. Each clean pile is designated by a sign. The pile of wood appeared to be the largest. Piles that are covered with a black tarp contain flight risks, ie garbage. The piles appeared to be managed in accordance with dust control and storm water requirements. The crew also sprays the radiation screening yard (RSY) pads to keep the dust from becoming suspended in the air as well. The crew noted that the wind is the worst in the afternoon.

Image 4. Pile appears green in photo due to soil adhesive.

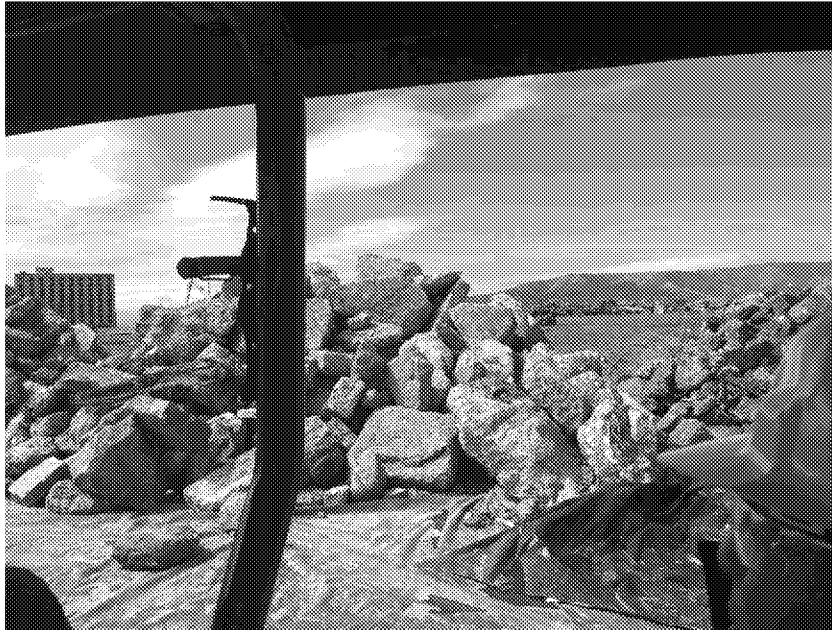
Image 5. Large rocks that are found are put into piles. These might interfere with the radiation screening.

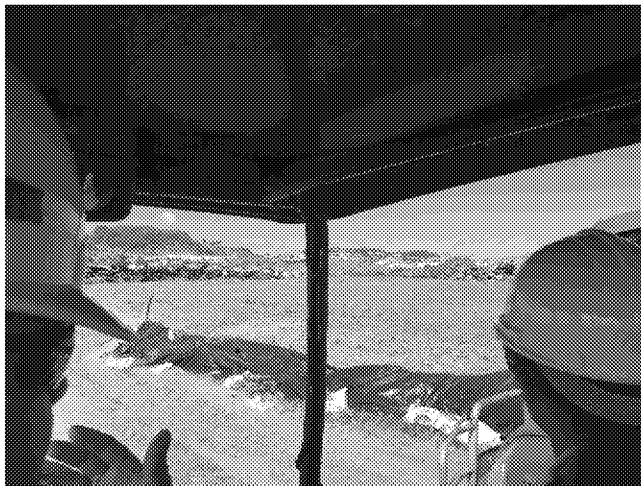
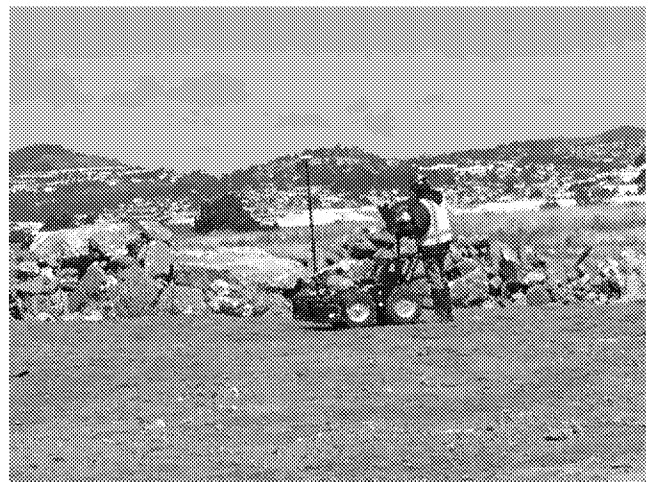
CB&I are using the RSI system (gigantic sodium-iodide detector) checking for energy levels. With respect to the RSY pads, the crew noted no significant issues. They reiterated that they try to keep rocks greater than 6 inches out of the pads. They scan at a rate of a quarter meter per second. Although the RSI can see accurately for 12 inches, CB&I are using a 9 inch screening limit to be conservative. We noticed many small pink flags marking certain areas in the soil reflecting that an HP will look more closely at these areas.

Images 6 and 7. Pink flags represent where HPs will have to come back and look.

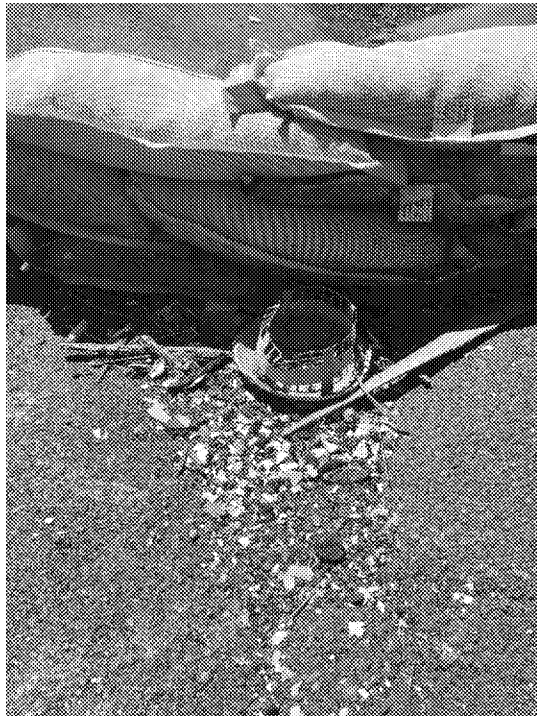
In terms of the lead chips monitoring, we observed the swell in between building 281, 214 and 252. We saw quite a few paint chips there. The swell between buildings 252 and 281 was as expected, no paint chips. While observing the swells in Parcel C, we discovered that some sand bags around a storm drain appear to be old and ripped open. Jaunita offered to follow up with the PRP to get these replaced.

Image 8. Many large and small paint chips in a storm water swell.

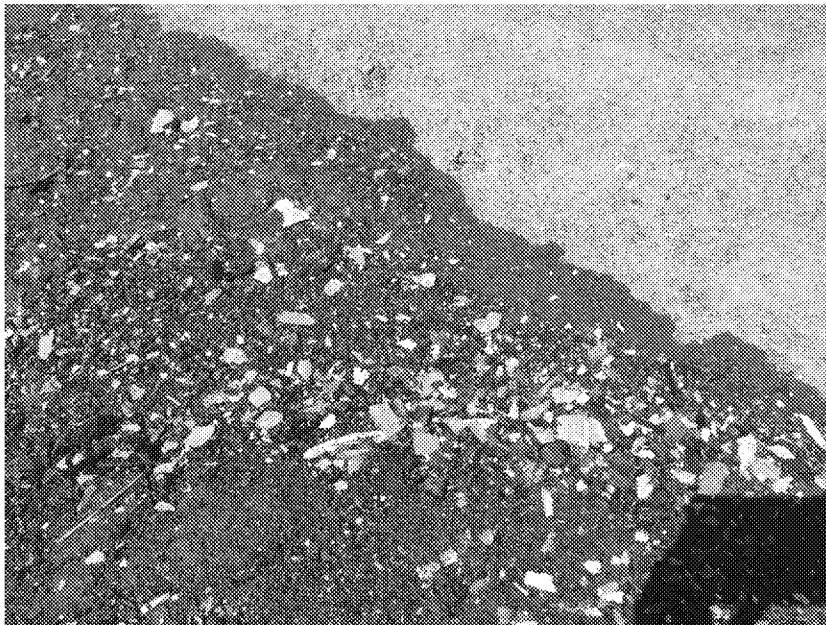
Image 9. Close up of paint chips.
